ASSESSMENT 2

Lake Kate Sheppard:

An exemplar mahinga kai site?

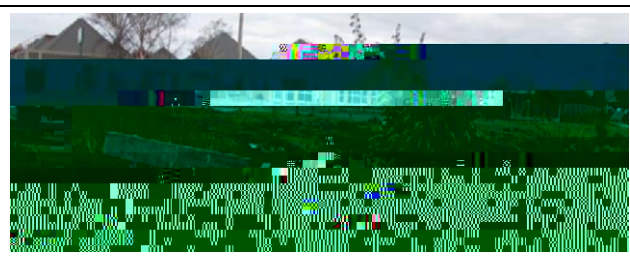
The seismic events of 2010 and 2011 also had major effects on the structure of the banks and the shoreline plantings. The liquefaction not only placed significant amounts of silt through the plants but also damaged large areas of plants. A comparison of the shoreline for pre and post seismic events can be seen in Figures 15 and 16. Remedial action needs to be completed to replace/restore the shoreline planting to provide a suitable habitat for inanga to lay their eggs. This needs to cater for a mean water level and the plants chosen require some resilience for the fluctuating water level from high water events, tidal surges and flooding as well as low water events. Planting should also incorporate plants to reduce the impact of Canadian geese and the residue that they create as this can be prolific and further reduce water quality.

Fig 16. Shoreline post earthquake
